Amtrak Passenger Train 501 Derailment
DuPont, Washington
December 18, 2017

NTSB/RAR-19/01
PB2019-100807

Railroad Accident Report

Abstract: On December 18, 2017, at 7:34 a.m. Pacific standard time, southbound Amtrak (National Railroad Passenger Corporation) passenger train 501, consisting of 10 passenger railcars, a power railcar, a baggage railcar, and a locomotive at either end, derailed from a bridge near DuPont, Washington. When the train derailed, it was on its first revenue service run on a single main track (Lakewood Subdivision) at milepost 19.86. There was one run for special guests the week before the accident. Several passenger railcars fell onto Interstate 5 and hit multiple highway vehicles. At the time of the accident, 77 passengers, 5 Amtrak employees, and a Talgo, Inc., technician were on the train. Of these individuals, 3 passengers were killed, and 57 passengers and crewmembers were injured. Additionally, 8 individuals in highway vehicles were injured. The damage is estimated to be more than \$25.8 million. The accident investigation focused on the following issues: individual agency responsibilities in preparation for inaugural service, multiagency participatio

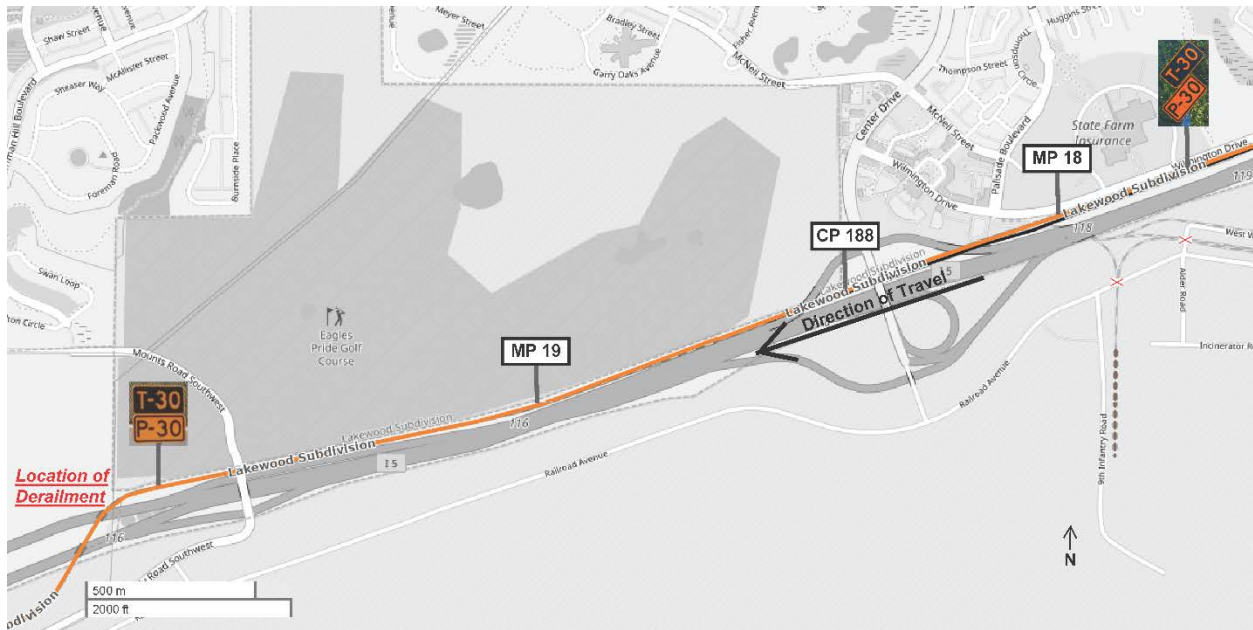
Figure 4. Location of signage on the approach to MP 19.8.

NTSB investigators were able to identify the advanced warning board sign at MP 17.8 while watching the outward-facing video. The BLET local chairman told investigators, “We don’t normally use the advanced board, but you got to...especially in a new territory.” Amtrak’s road foreman of engines OJT told investigators, “An advanced speed board doesn’t really have any effect on their operation because it’s just too far out...to be of any use to them for braking for a curve 2 miles away.” He added that some engineers may opt to brake earlier than 1 mile from the curve because of the downhill grade and the need to reduce the train’s speed from 79 mph to 30 mph as they approach the curve. (See figure 4.)

NTSB investigators also viewed the locomotive’s outward-facing video to assess the conspicuity of the wayside signs at MP 18 and CP 188. Investigators noted that the sign at MP 18 became conspicuous after the train had passed a grade crossing at MP 17.34. After the crossing, the MP 18 sign was visible for up to 10 seconds, although the numbers on the sign could not be read until the train was about 4 seconds away. NTSB investigators noted that when the train approached the sign, headlights from automobiles heading north on a street that ran parallel to the tracks could be seen from the operating compartment. However, the automobile headlights did not appear to ‘wash out’ the sign.

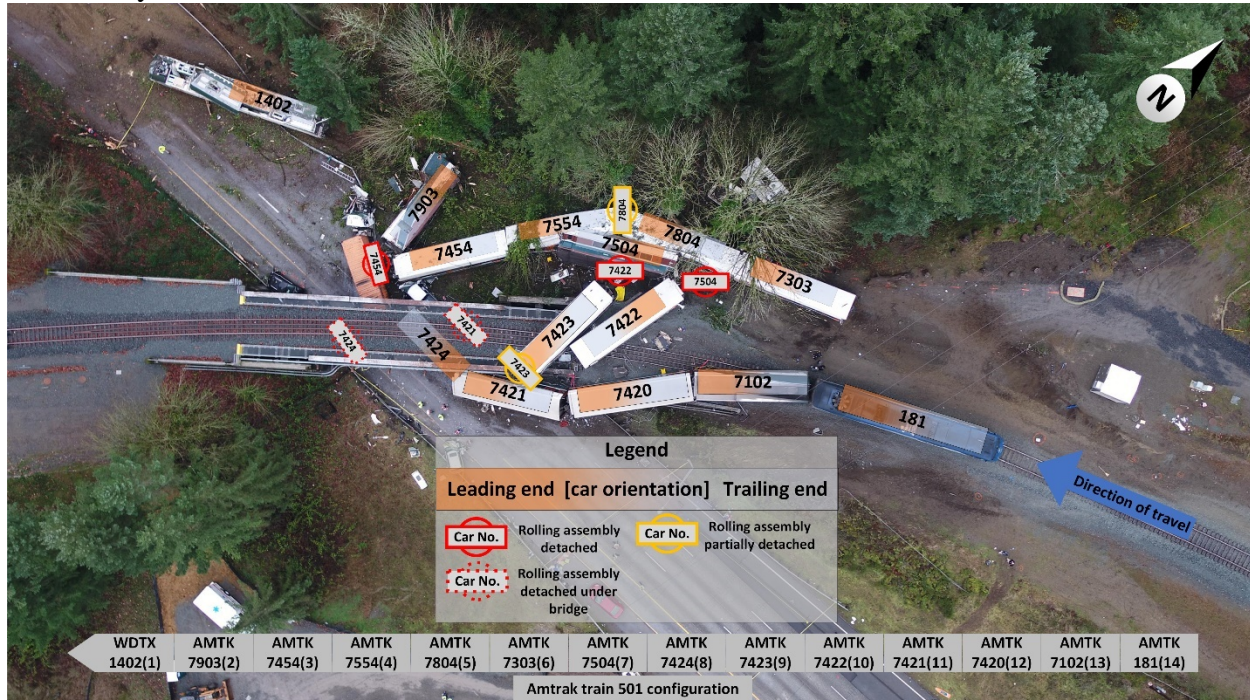
Figure 10. Overhead with railcar positions labeled. Railcar 7421 was on top of railcar 7424, which is faded because it was under the overpass. (Photo provided by WSP.)

The resting location of train 501 following the derailment is shown in figure 10. The locomotives, passenger railcars, and detached rolling assemblies are labeled and will be discussed individually.

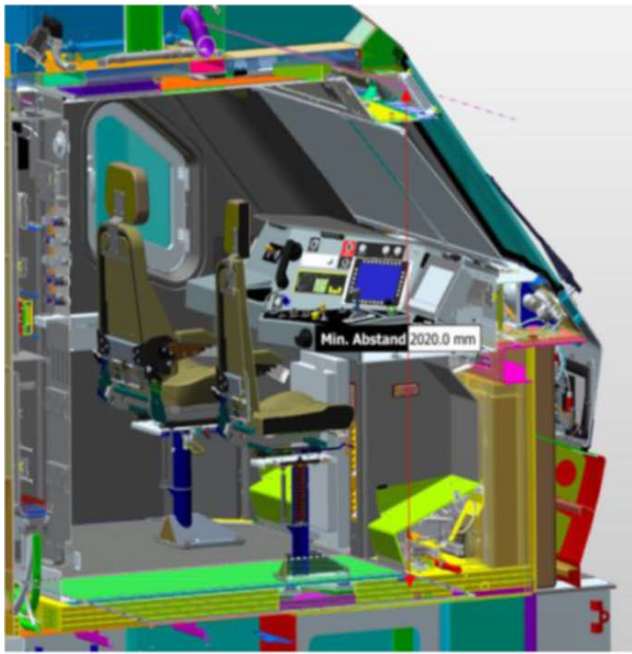
Damage to the interior of the operating cab was constrained primarily to the leading end, most notably at and above the front glazing (windshield). The vertical space of the cab interior was reduced to about 19 inches between the operator's desk and the ceiling, and to 66 inches from the floor to the ceiling. The height above the seats was reduced to 66.5 inches. All doors, both side doors, and the machinery room access door, were fully functional after the accident. The cab ceiling emergency exit hatch was dislodged from the vehicle. The hatch is comprised of two parts; the upper, or outer, part came to rest in the wooded area between the track and the interstate, and the inner portion was inside the cab. Investigators estimated the locomotive lost about 5 percent of its occupied volume in the cab. Figure 19 is a cutaway illustration of the locomotive cab showing the cab design and underlying structure and an interior photograph of the accident cab taken from the left side of the cab towards the engineer's seat on the right.

Photograph of damaged locomotive cab.

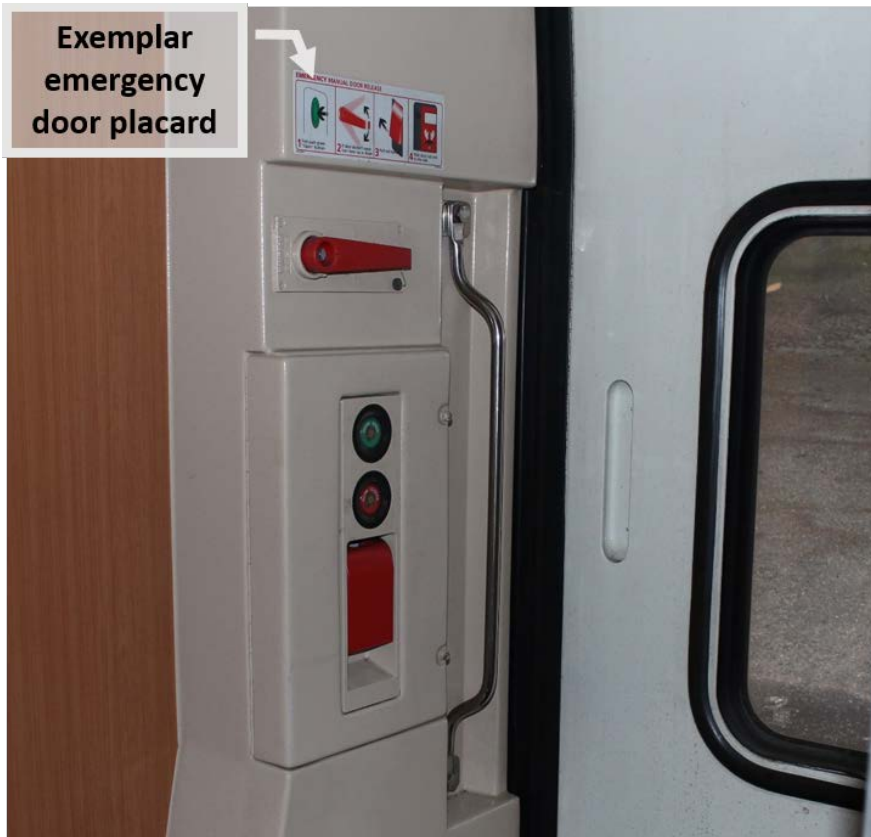
Figure 37. Exemplar emergency door showing instruction placard.

present but did not possess the required photoluminescence by regulation. The derailment occurred prior to sunrise. (See figure 37.)
