Amtrak Passenger Train 501 Derailment
DuPont, Washington
December 18, 2017

NTSB/RAR-19/01
PB2019-100807

Railroad Accident Report

Abstract: On December 18, 2017, at 7:34 a.m. Pacific standard time, southbound Amtrak (National Railroad Passenger Corporation) passenger train 501, consisting of 10 passenger railcars, a power railcar, a baggage railcar, and a locomotive at either end, derailed from a bridge near DuPont, Washington. When the train derailed, it was on its first revenue service run on a single main track (Lakewood Subdivision) at milepost 19.86. There was one run for special guests the week before the accident. Several passenger railcars fell onto Interstate 5 and hit multiple highway vehicles. At the time of the accident, 77 passengers, 5 Amtrak employees, and a Talgo, Inc., technician were on the train. Of these individuals, 3 passengers were killed, and 57 passengers and crewmembers were injured. Additionally, 8 individuals in highway vehicles were injured. The damage is estimated to be more than \$25.8 million. The accident investigation focused on the following issues: individual agency responsibilities in preparation for inaugural service, multiagency participatio

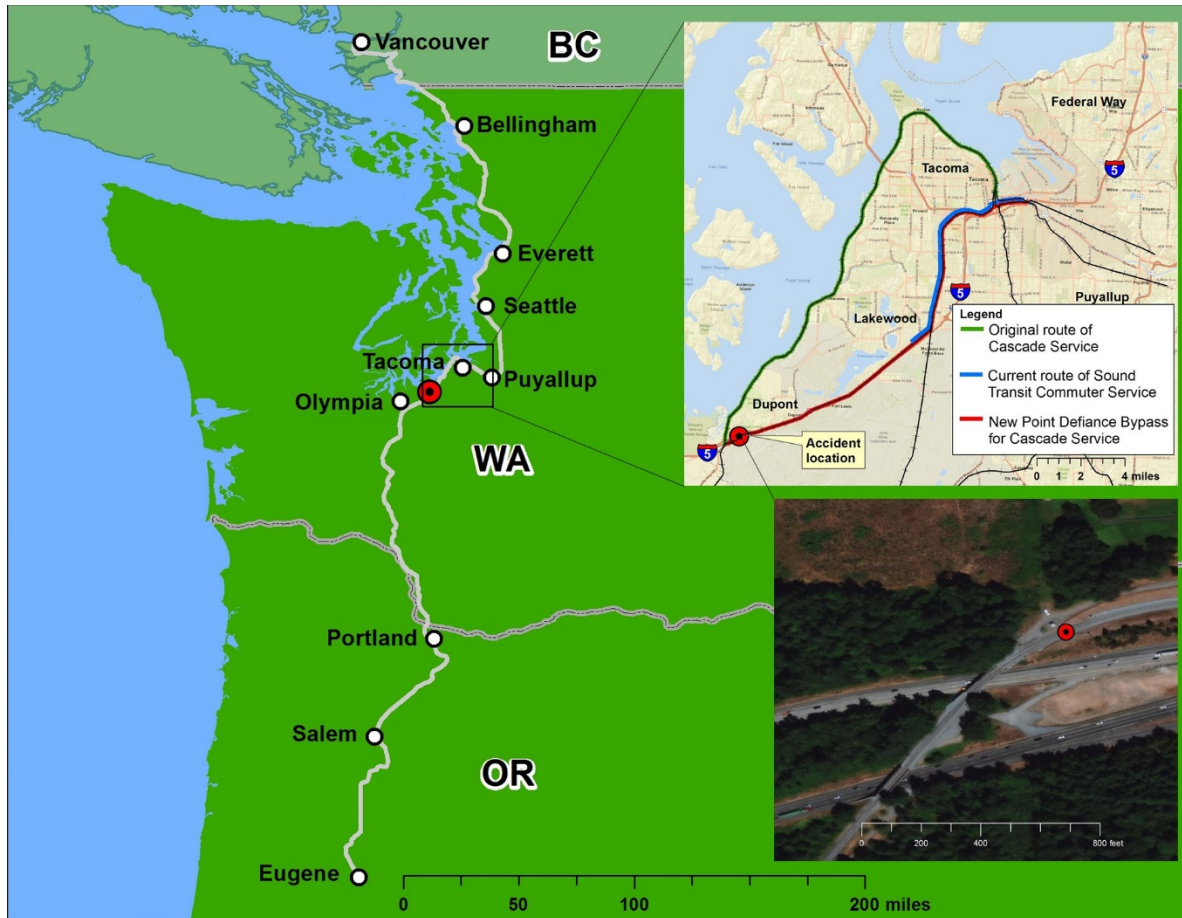
Figure 1. Accident location and Point Defiance Bypass.

On December 18, 2017, at 7:34 a.m., Pacific standard time, southbound Amtrak (National Railroad Passenger Corporation) passenger train 501, consisting of 10 passenger railcars, a power railcar, a baggage railcar, and a locomotive at both ends, derailed from a highway overpass near DuPont, Washington. (See figure 1.)

When the train derailed, it was on its first revenue service run on a single main track (Lakewood Subdivision) at milepost (MP) 19.86. Several passenger railcars fell onto Interstate 5 (I-5) and hit multiple highway vehicles. At the time of the accident, 77 passengers, 5 Amtrak employees, and a Talgo, Inc. technician were on the train.¹ Of these individuals, 3 passengers were killed, and 57 passengers and crewmembers were injured. Additionally, 8 individuals in highway vehicles were injured. The damage is estimated to be more than \$25.8 million. At the time of the
